# Manhole Inspection Summary

Manhole # S29E\_\_034MH

**Inspection** ☐ Is Incomplete Rating: **3) Fair**

**Location** Address: **680 N Pine St**

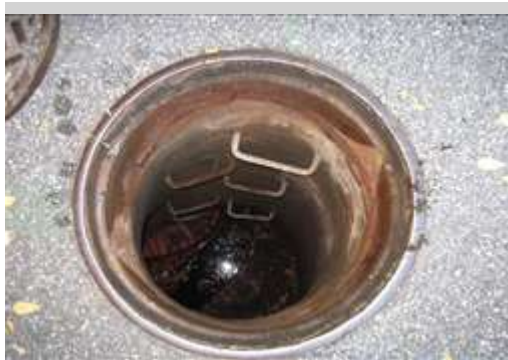
Frame View

Condition: ☐ Sound ☐ Cracked ☒ **Leaks**

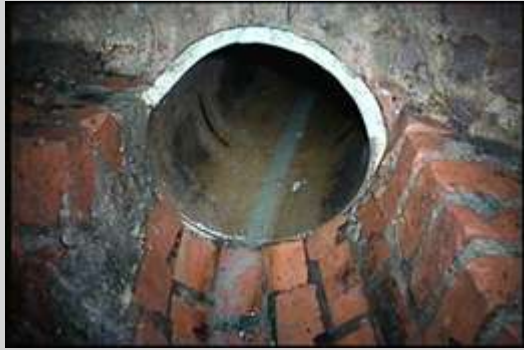
9 O'Clock Inflow

Pipe Height: **10.8** (in.) Rod and Bar (Angled)

Pipe Material: **Clay** ☐ Pipe Lined

Infiltration: **None** Pipe Seal Cond: **Sound**
